Re: Reconnaissance Inspection within the Autonomous Municipality of San Juan (MSJ) and Puerto Rico Aqueduct and Sewer Authority (PRASA) Collection Systems.  
Autonomous Municipality of San Juan (MSJ) MS4 (PRR040036)  
Puerto Rico Aqueduct and Sewer Authority (PRASA) Puerto Nuevo Wastewater Treatment Plant Collection System (PR0021555)

**SANTURCE'S RIBOT STREET STORM WATER AND WASTEWATER  
COLLECTION SYSTEMS**

Reconnaissance Inspection: Autonomous Municipality of San Juan (MSJ) Municipal Separate Storm Sewer System (MS4)  
National Pollutant Discharge Elimination System (NPDES) Permit (PRR040036)  
Puerto Rico Aqueduct and Sewer Authority ("PRASA") Puerto Nuevo Regional Wastewater Treatment Plant (RWWTP) NPDES Permit (PR0021555)

Inspection Date: January 23, 2015

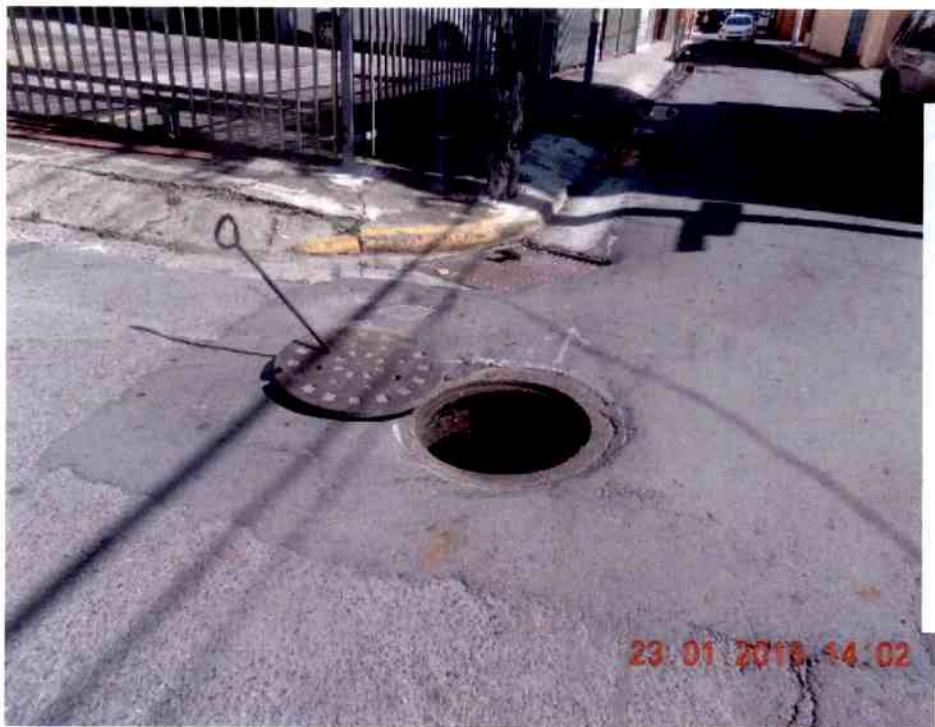
1. A wastewater manhole located in front of Ribot Street's residence #1154 and in the corner of Valencia and Ribot Streets intersection (northeast side) was found surcharged.

**DSCN1696:** Wastewater manhole located in front of Ribot Street's Residence #1154 and in the corner of Valencia and Ribot's Streets intersection (northeast side).

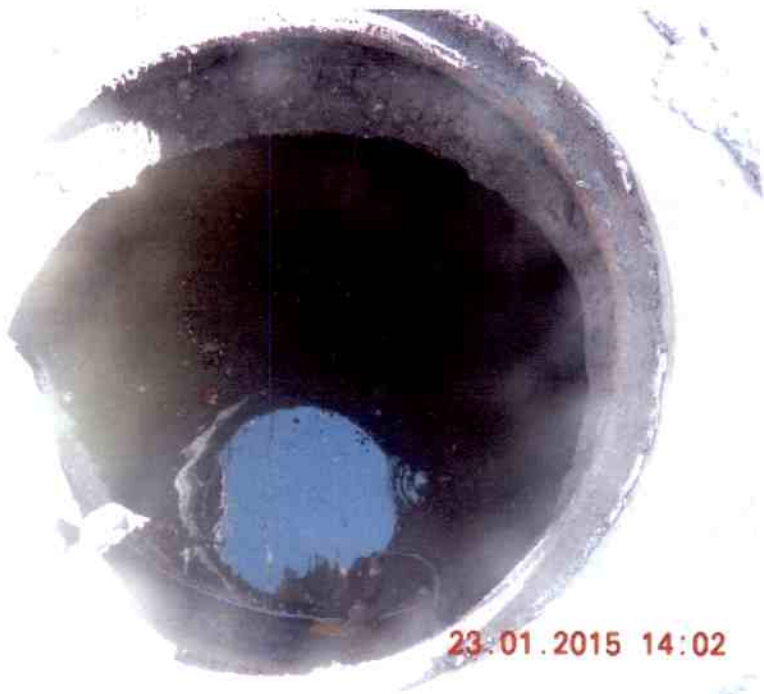
**DSCN1697:** The wastewater manhole located in front of Ribot Street #1154 described in photo DSCN1696 was found surcharged.

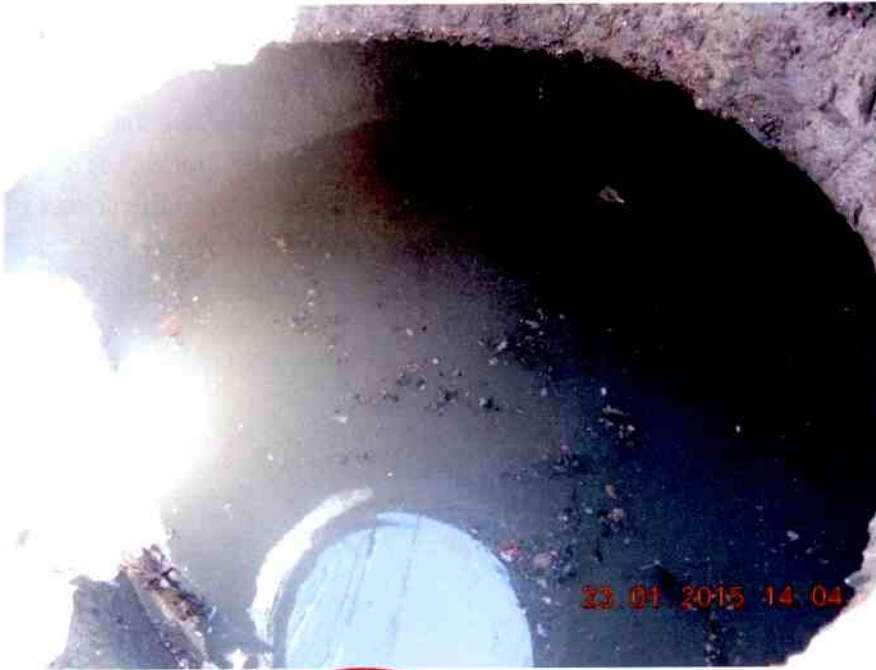
**DSCN1698** – Additional view of the wastewater manhole located in front of Ribot Street #1154 described in photo DSCN1696 and 1697. The manhole was found surcharged.

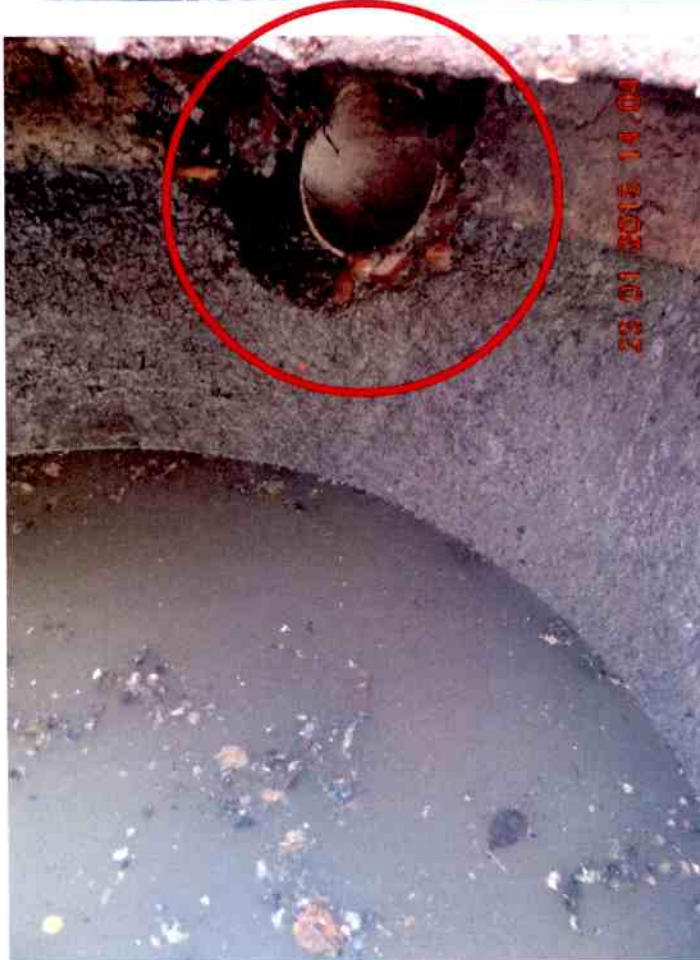
See Attachment I photos DSCN1696 thru 1700 for more details. An approximately 4 inches PVC pipe was found connected to the upper part of the manhole, no discharge was observed, see photo DSCN1699 for more details.

**DSCN1699** - Additional view of the wastewater manhole located in front of Ribot Street #1154 described in photo DSCN1696 thru 1698. An approximately 4 inches PVC pipe was found connected to the upper part of the manhole, no discharge was observed.

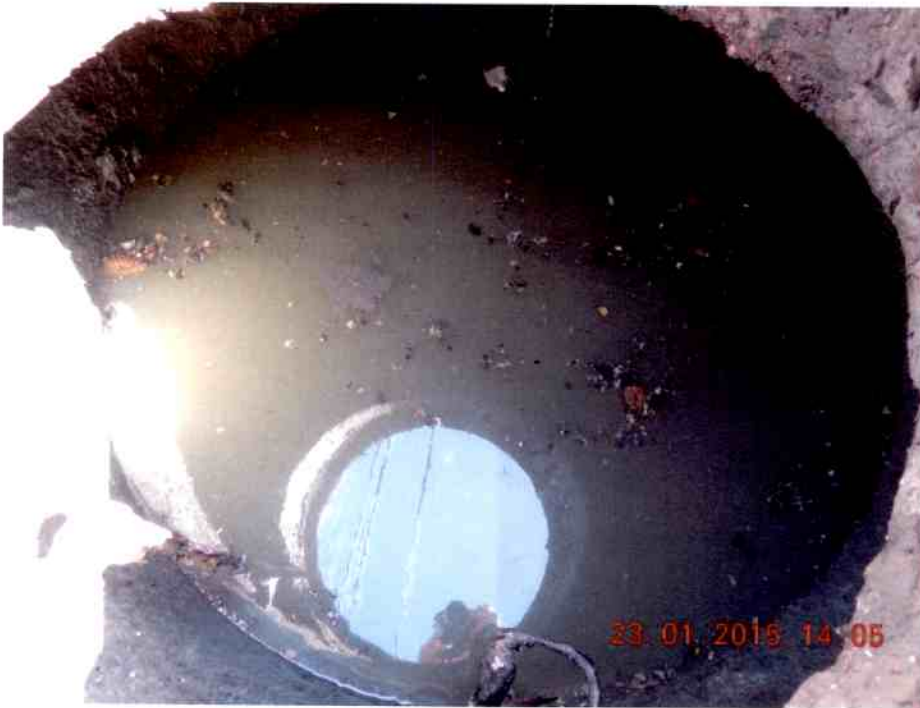
**DSCN1700** – Additional view of the surcharged wastewater manhole located in front of Ribot Street #1154 described in photo DSCN1696 thru 1699.

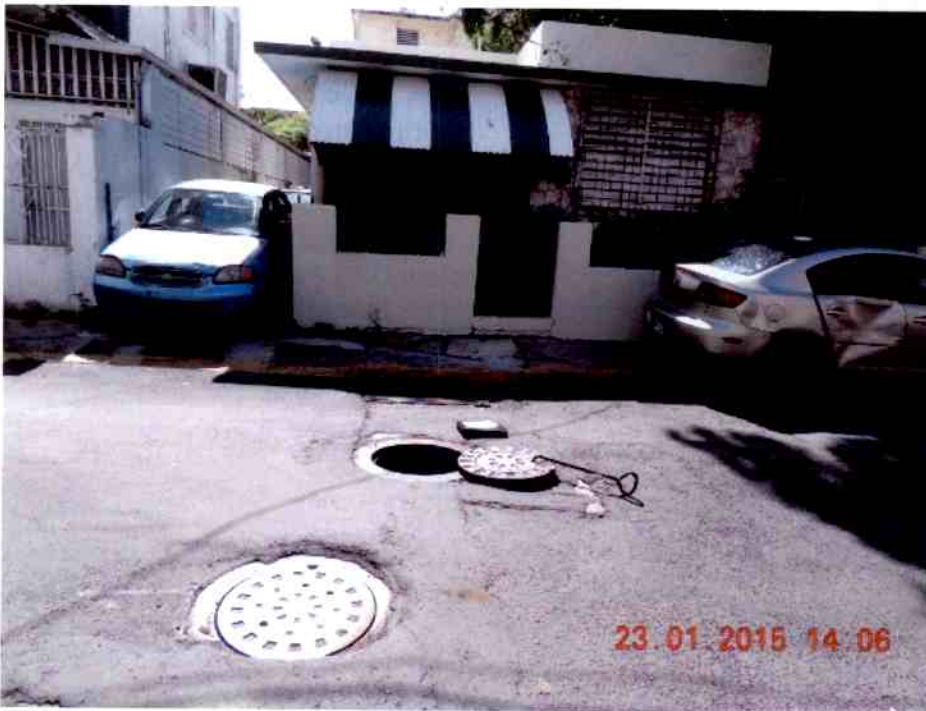
**DSCN1701** – View of Ribot Street residence #1154. The opened manhole in the photo is part of the storm water collection system.

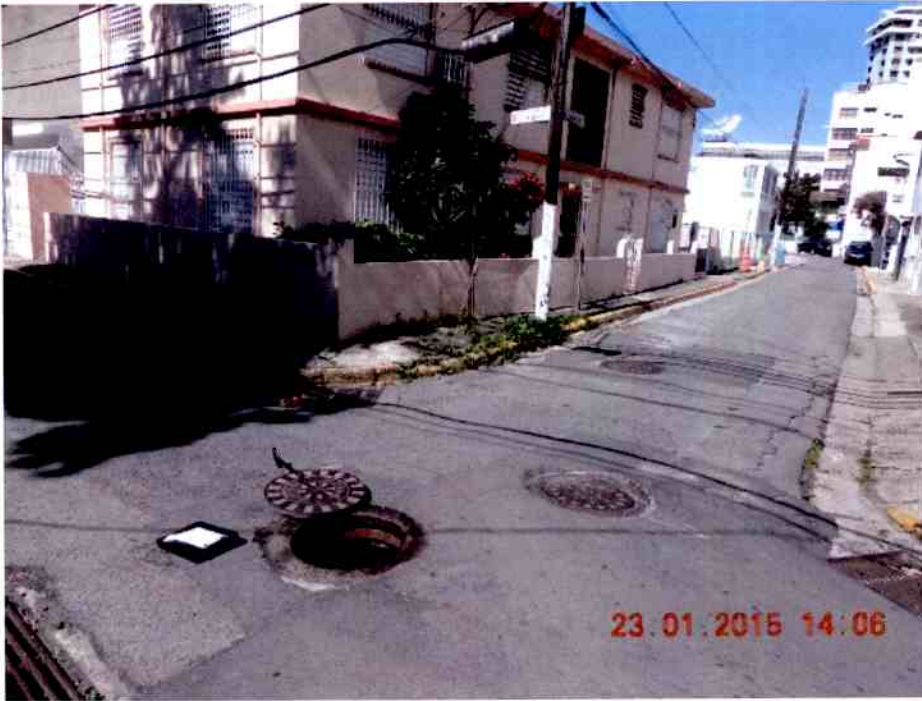
**DSCN1702** – View of Ribot and Valencia Streets intersection. The opened manhole in the photo is part of the storm water collection system and is located in front of Ribot Street's residence #1154.

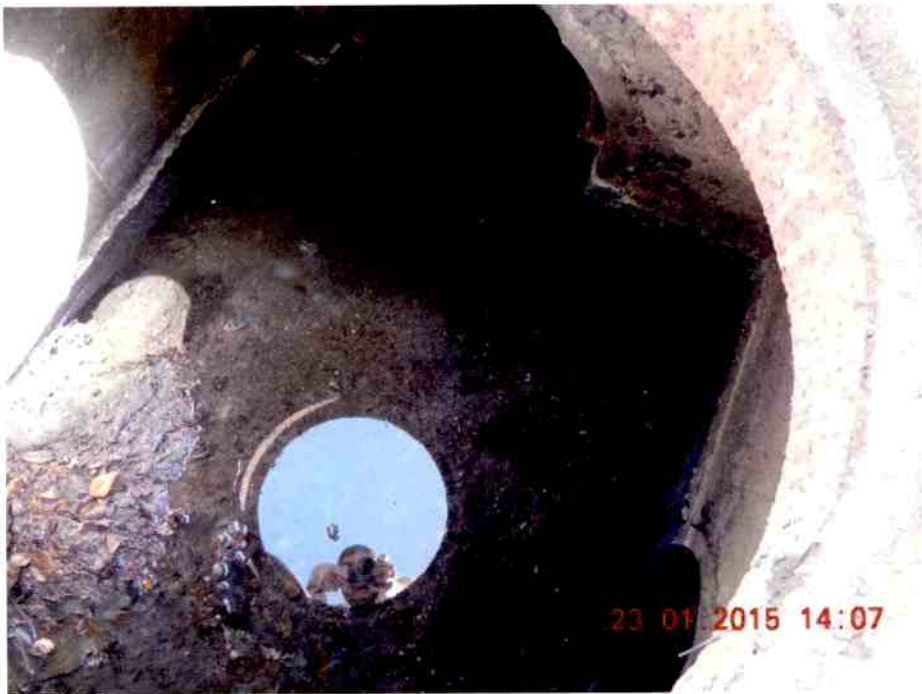
3. A storm water collection system manhole located in front of Ribot Street residence #1154 was found with stagnant water and no flow. See photos DSCN1701 thru 1703 for more details.

**DSCN1703** – Partial view of storm water manhole located in front of Ribot Street residence #1154. It was found with stagnant water and no flow.

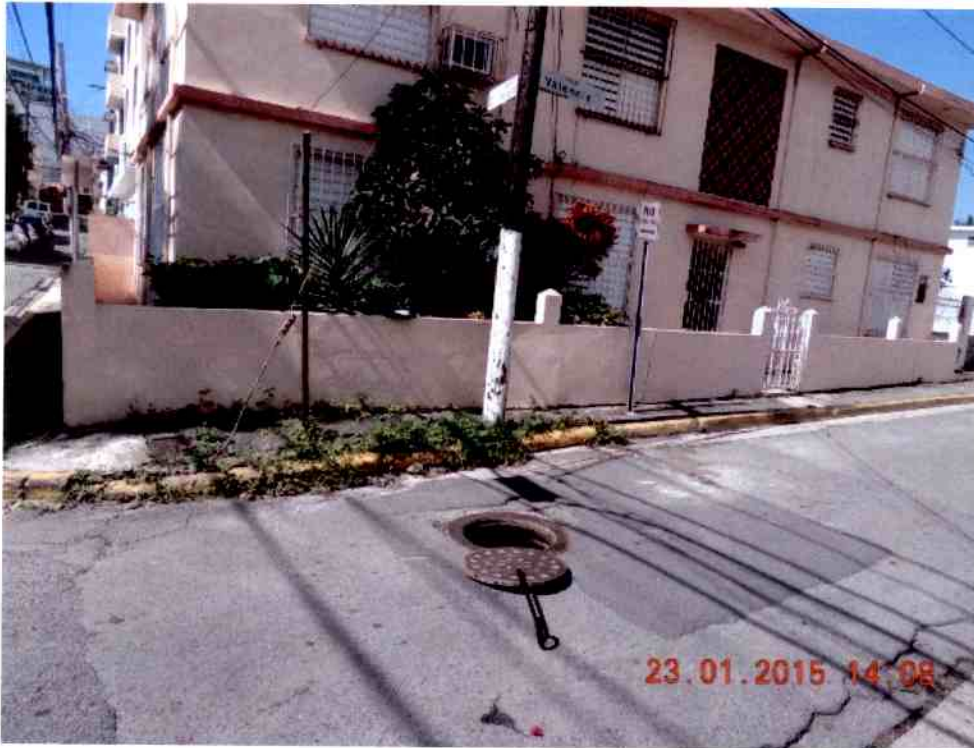
**DSCN1704** – View of wastewater manhole located in the corner of Valencia and Ribot Streets and in front of Valencia #1115 (northwest side).

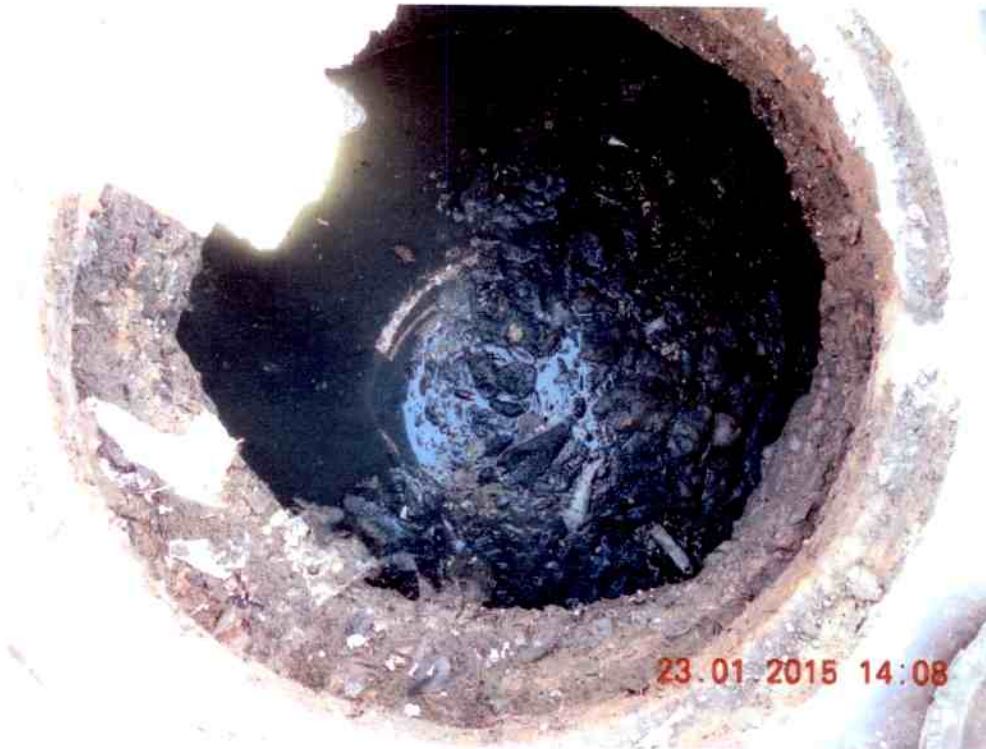
4. A wastewater manhole located in the corner of Valencia and Ribot Streets and in front of Valencia #1115 (northwest side) was found surcharged and with solids accumulation. Signs of recent overflows were also observed in the street curb. See photos DSCN1704 thru 1706 for more details.

**DSCN1705** – The wastewater manhole located in the corner of Valencia and Ribot Streets and in front of Valencia #1115 (northwest side) was found surcharged and with solids accumulation. Signs of recent overflows were also observed in the street curb.

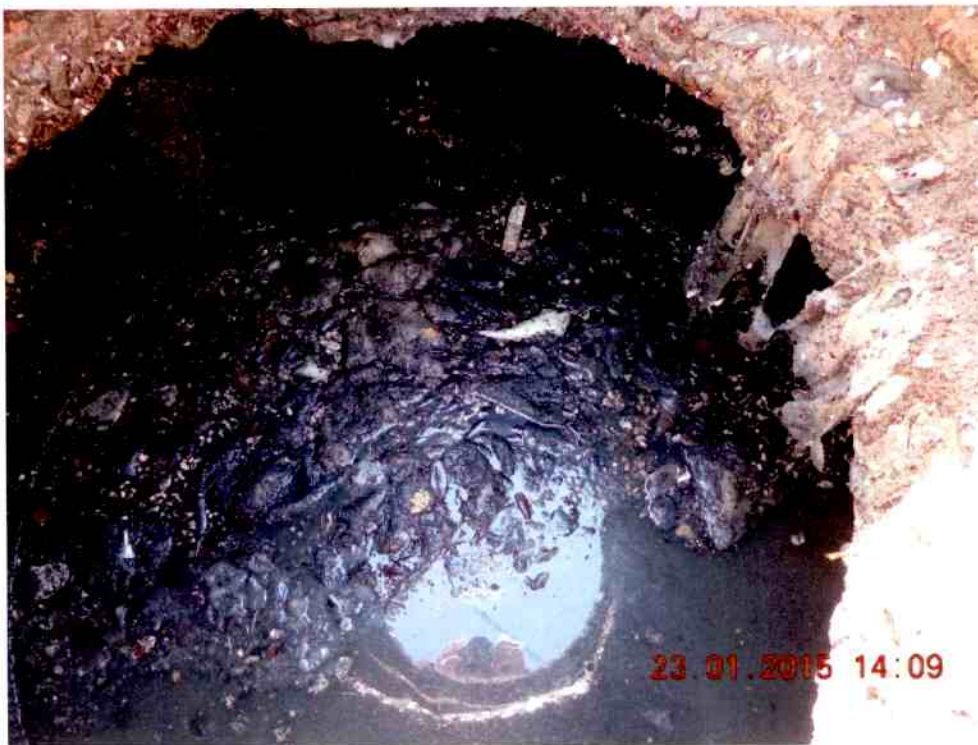
**DSCN1706** – Another view of wastewater manhole located in the corner of Valencia and Ribot Streets and in front of Valencia #1115 (northwest side) was found surcharged and with solids accumulation. Signs of recent overflows were also observed in the street curb.

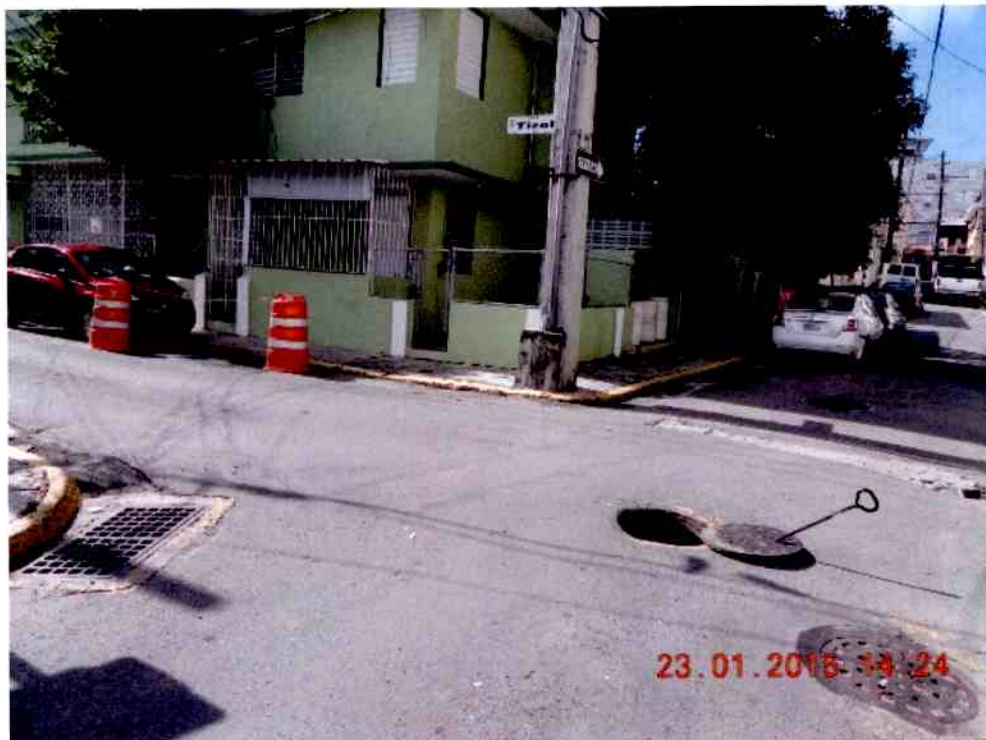
5. Two (2) manhole structures in Tizol and Ribot Streets intersection were found dry and full of solids and sand. The storm water catch basin located in the same intersection was found full of stagnant water. See photos DSCN1707 thru 1710 for more details.

**DSCN1707** – View of Ribot and Tizol Streets intersection. Two (2) manhole structures in Tizol and Ribot Streets intersection were found dry and full of solids and sand. The storm water catch basin located in the same intersection was found full of stagnant water.

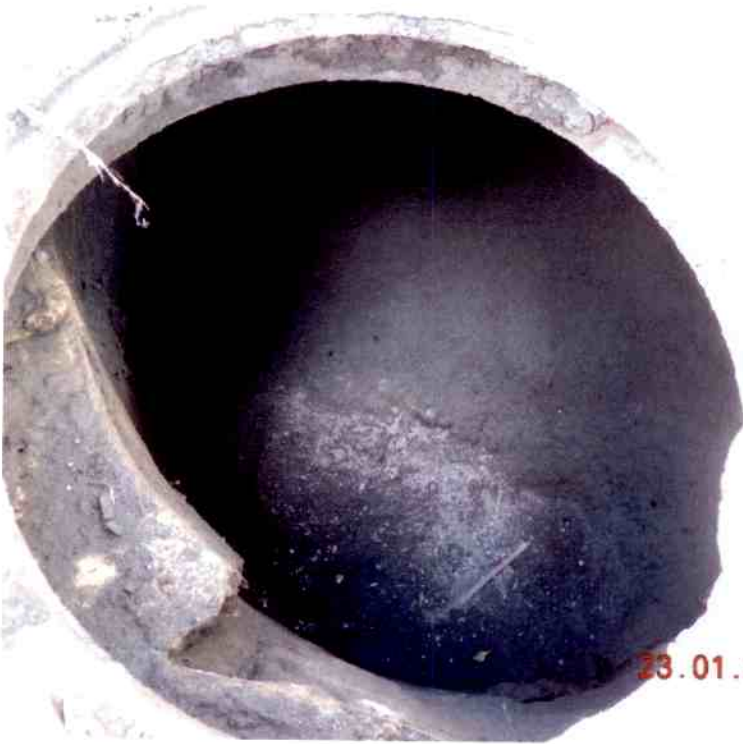
**DSCN1708** – Partial view of a manhole structure located in Ribot and Tizol Streets intersection. The manhole was found full of sand.

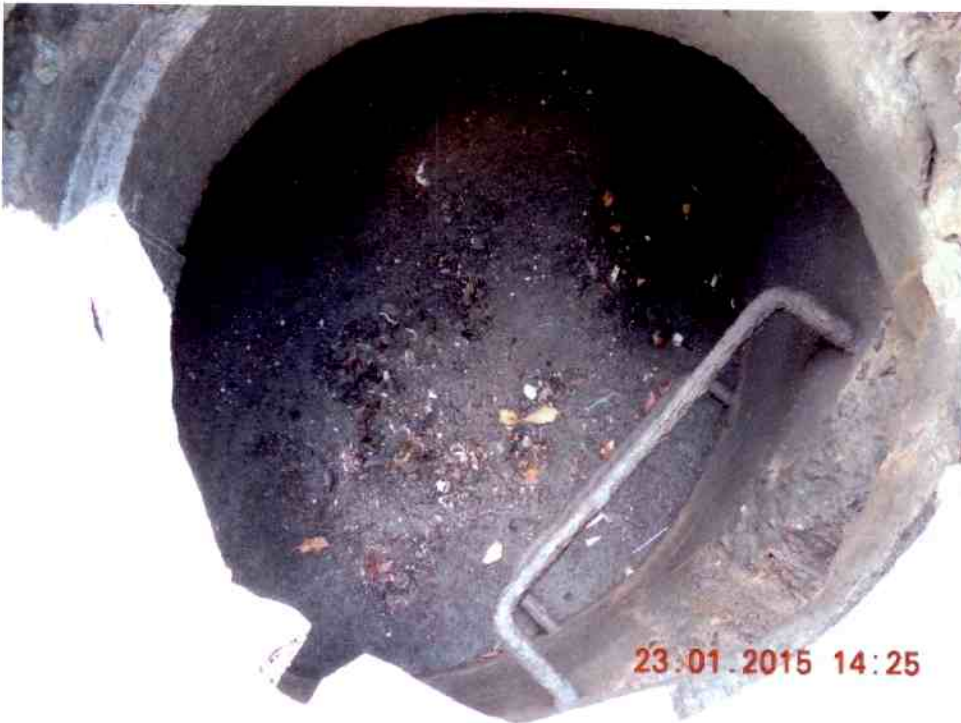
**DSCN1709** – Partial view of an additional manhole structure located in Ribot and Tizol Streets intersection. The manhole was also found full of sand and solids.

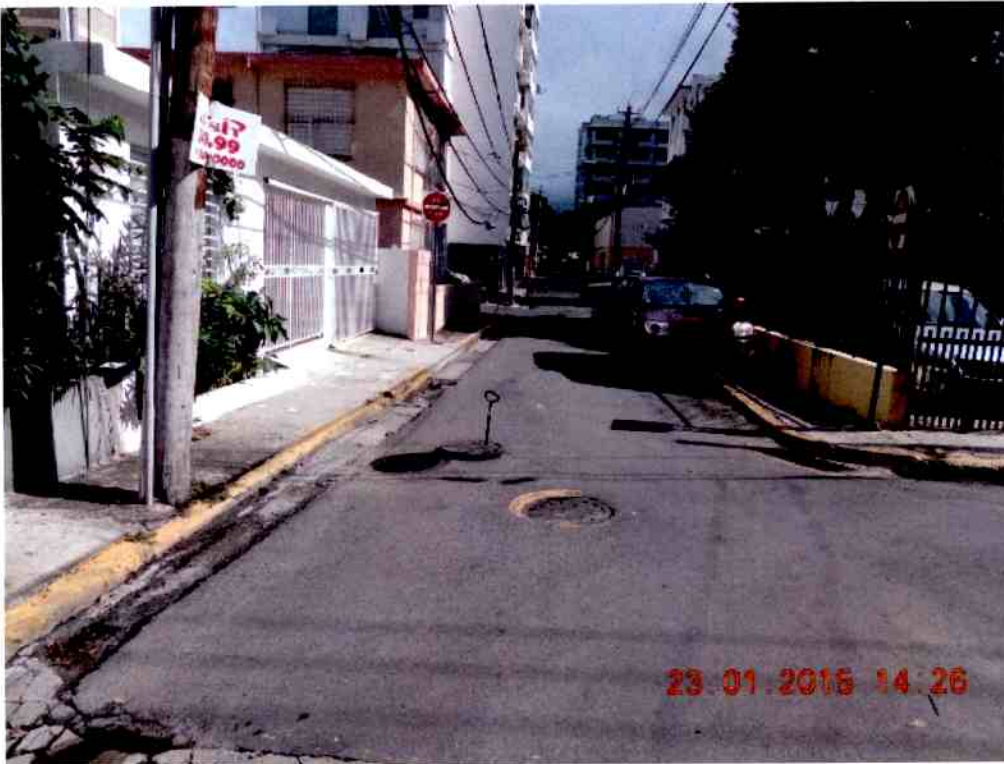
**DSCN1710** – Additional view of Ribot and Tizol Streets intersection. The opened manhole in the photo is the one showed and described in photo DSCN1709.

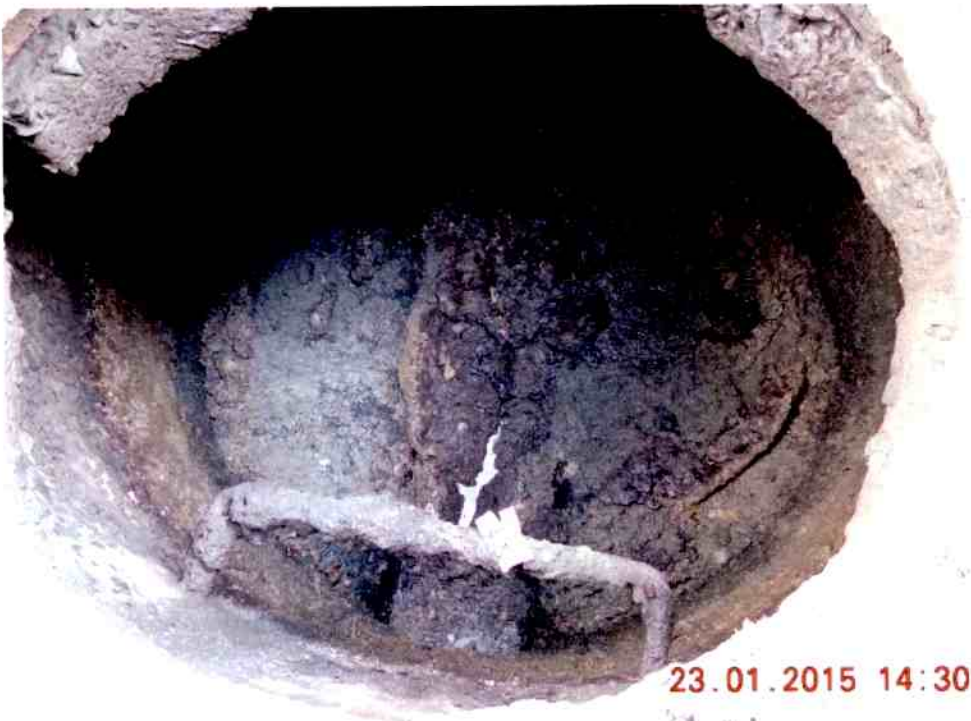
6. A wastewater manhole located in front of Ribot Street #1107 was found with significant amount of solids and grease accumulated on its bottom and clogging its half pipe. See photos DSCN1711 and 1712 for more details.

**DSCN1711** – View of wastewater manhole located in front of Ribot Street #1107. The manhole was found with significant amount of solids and grease accumulated on its bottom and clogging its half pipe.

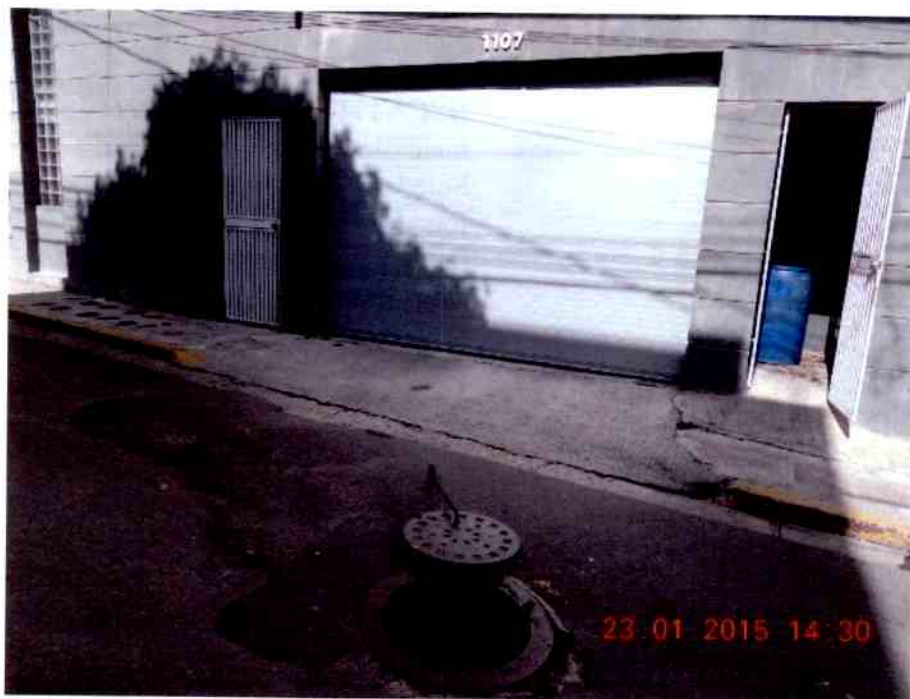
**DSCN1712** – View of wastewater manhole located in front of Ribot Street #1107 building and described in photo DSCN1711.

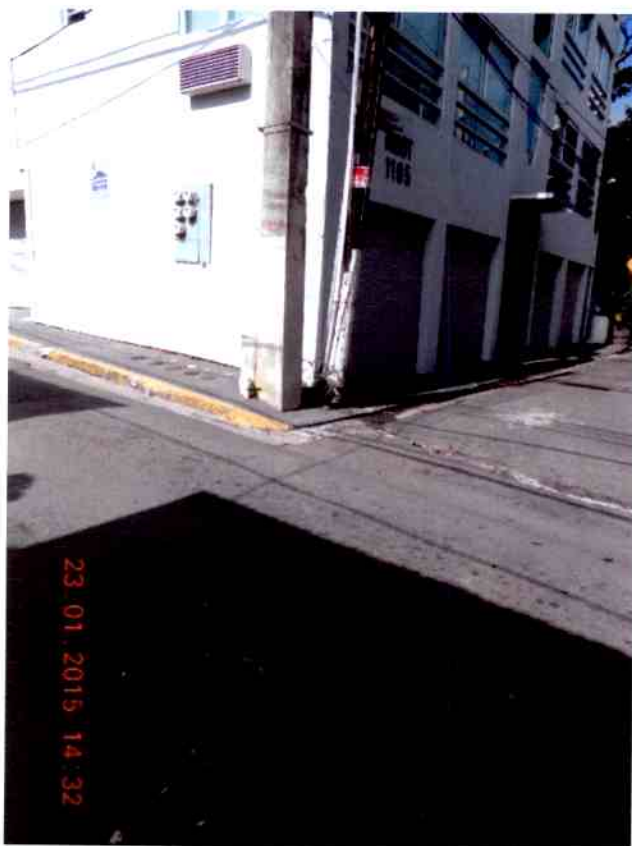
**DSCN1713** – View of wastewater manhole located in Ribot and Soledad Streets intersection.

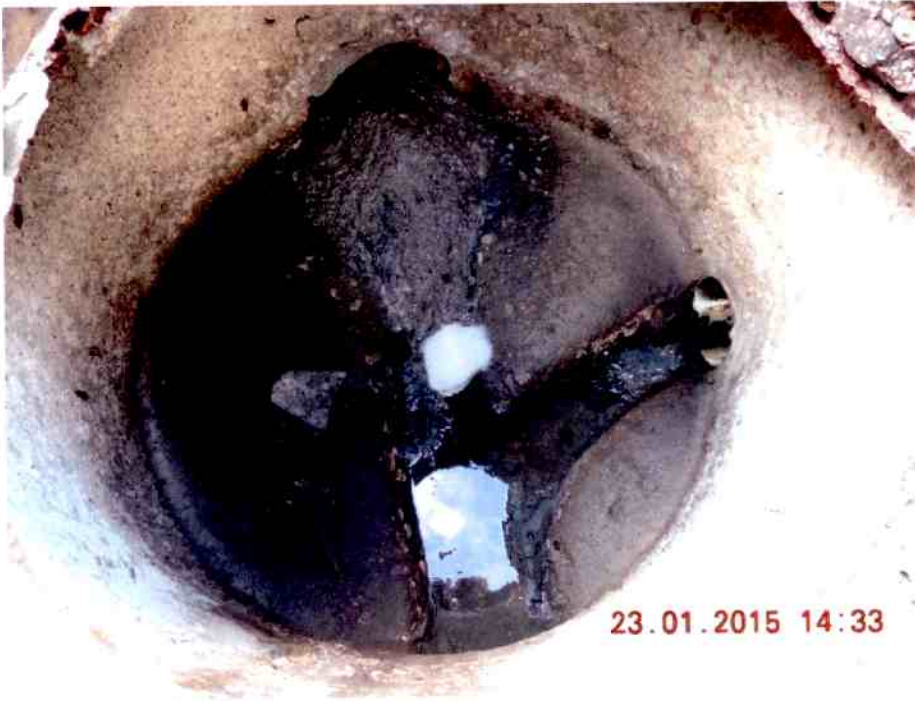
7. A wastewater manhole located in Ribot and Soledad Streets intersection was found flowing slowly and with low levels. Its pipe coming from Ribot and Barcelona Streets intersection was found partially obstructed by solids. See photos DSCN1713 and 1714 for more details.

**DSCN1714** – A wastewater manhole located in Ribot and Soledad Streets intersection was found flowing slowly and with low levels. Its pipe coming from Ribot and Barcelona Streets intersection was found partially obstructed by solids.

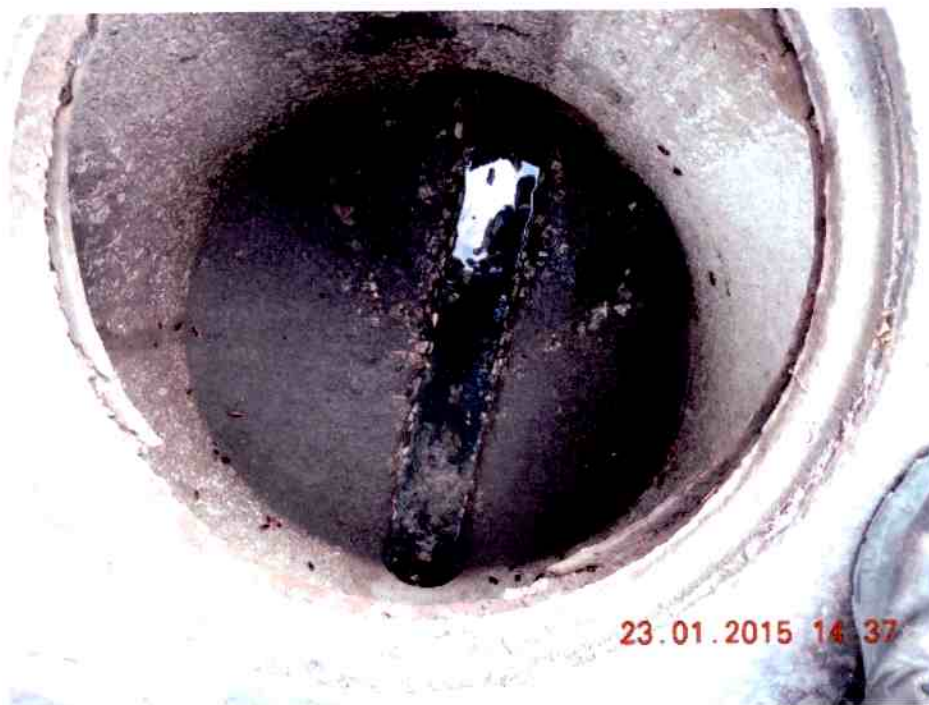
**DSCN1715** – A wastewater manhole in front of Valencia Street #113 was found flowing slowly and with low levels.

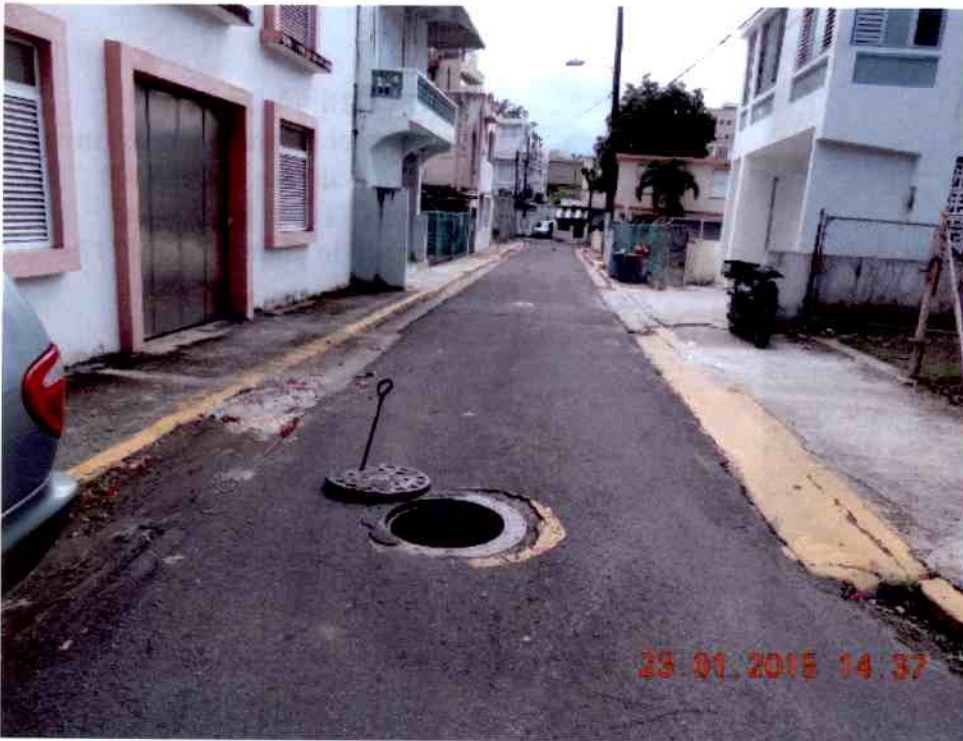
**DSCN1716** – View of wastewater manhole located in front of Valencia Street #113.

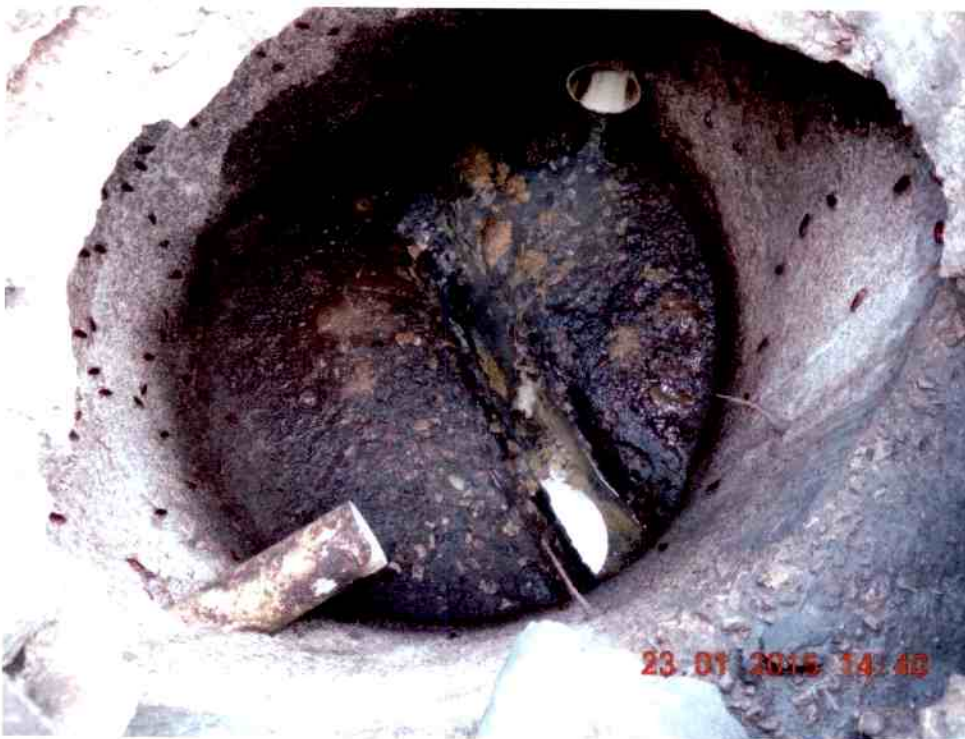
**DSCN1717** – View of wastewater manhole in front of Valencia Street #109 was found flowing slowly. Two (2) PVC pipes were observed connected directly into the wastewater manhole.

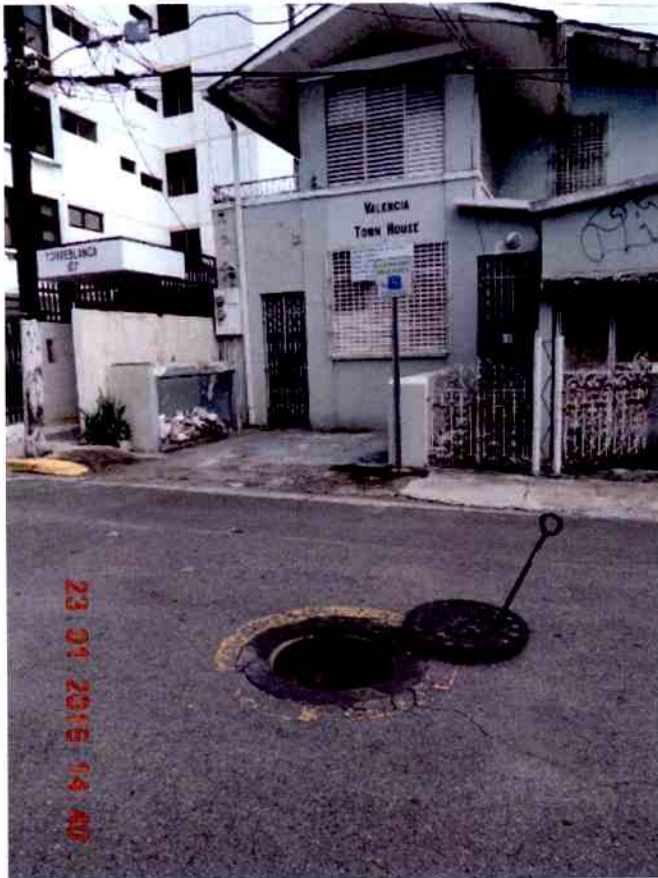
**DSCN1718** – View of wastewater manhole located in front of Valencia Street #109 (Valencia Town House) and described in photo DSCN1717.

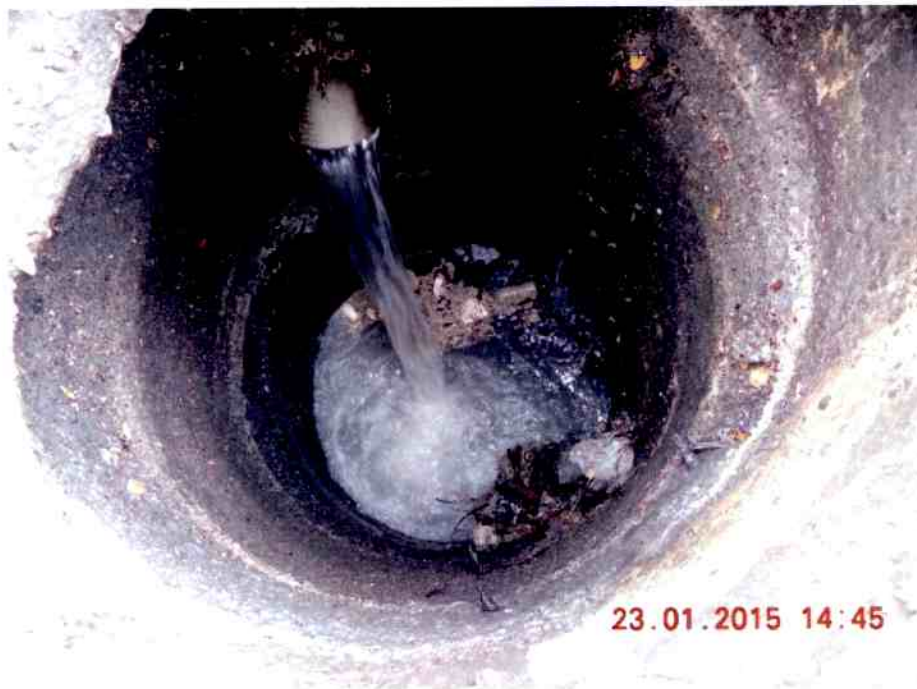
10. A wastewater manhole located west side of Ribot and Condado Streets intersection was found with high levels and accumulation of solids and grease. One of the pipes entering the structure from the south side of the intersection was found partially obstructed. The pipe entering the structure from its west side was found obstructed. Significant amount of flow was observed flowing from the east side on the intersection. See photos DSCN1719 and 1720 for more details.

**DSCN1719** – View of wastewater manhole located west side of Ribot and Condado Streets intersection was found with high levels and accumulation of solids and grease. One of the pipes entering the structure from the south side of the intersection was found partially obstructed. The pipe entering the structure from its west side was found obstructed. Significant amount of flow was observed flowing from the east side on the intersection.

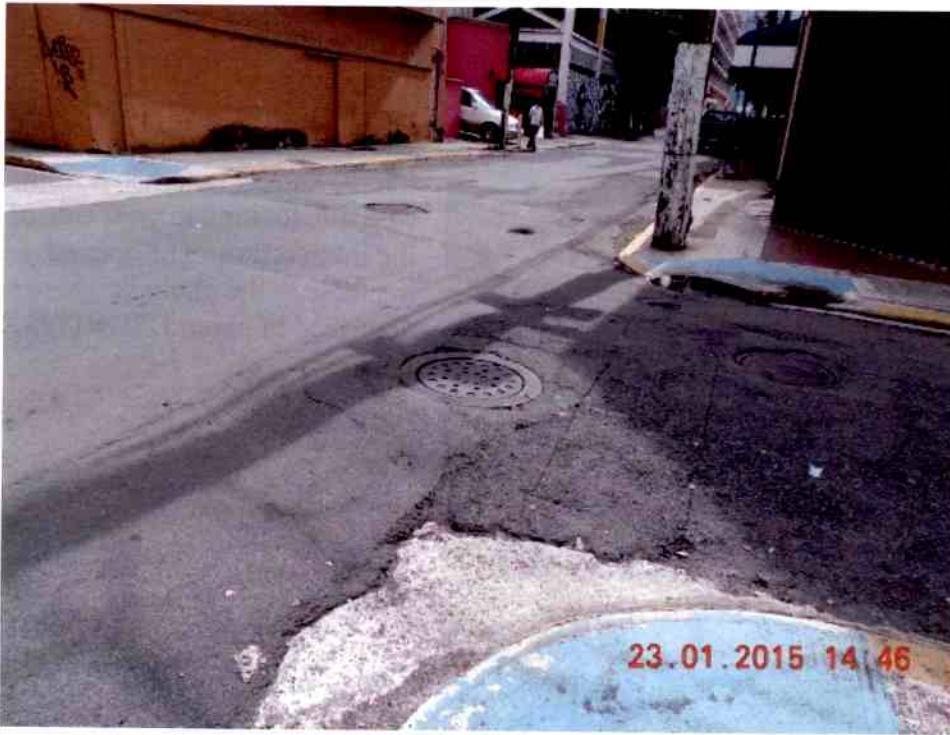
**DSCN1720** – View of west side of Ribot and Condado Streets intersection.

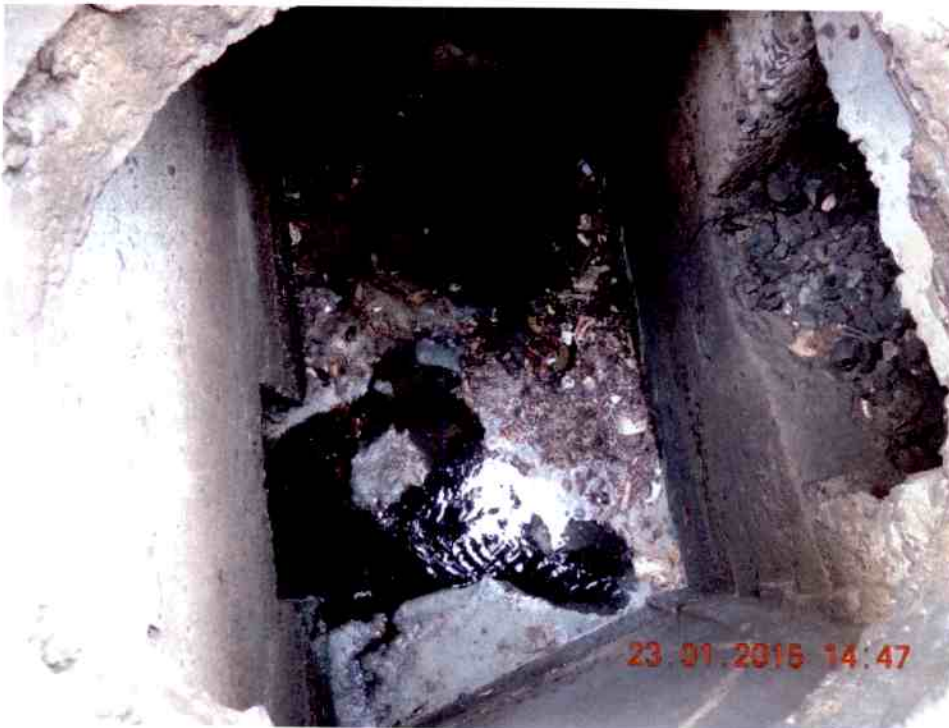
11. The storm water manhole located west side of the Ribot and Condado Streets intersection was found with traces of grease and wastewater characteristics (e.g. color, solids). See photo DSCN1721 for more details.

**DSCN1721**– Partial view of stormwater manhole located west side of the Ribot and Condado Streets intersection was found with traces of grease and wastewater characteristics (e.g. color, solids).

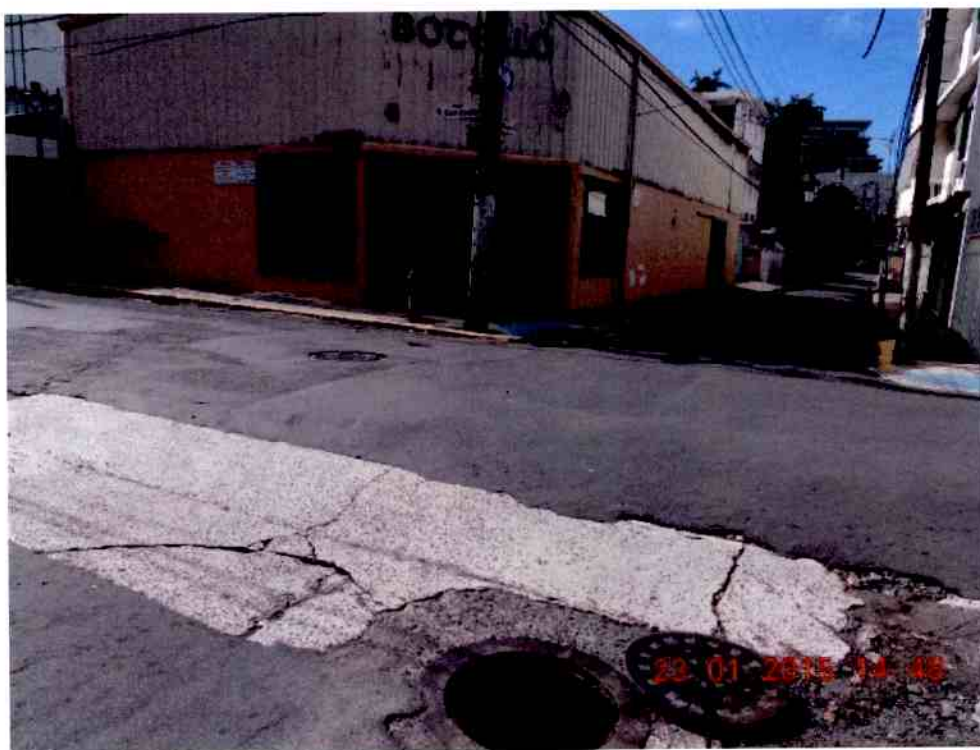
**DSCN1722** – View of Ribot and Condado Streets intersection. Photo taken from east side looking to west side of the intersection. The opened manhole in the photo is described in photo DSCN1723 below.

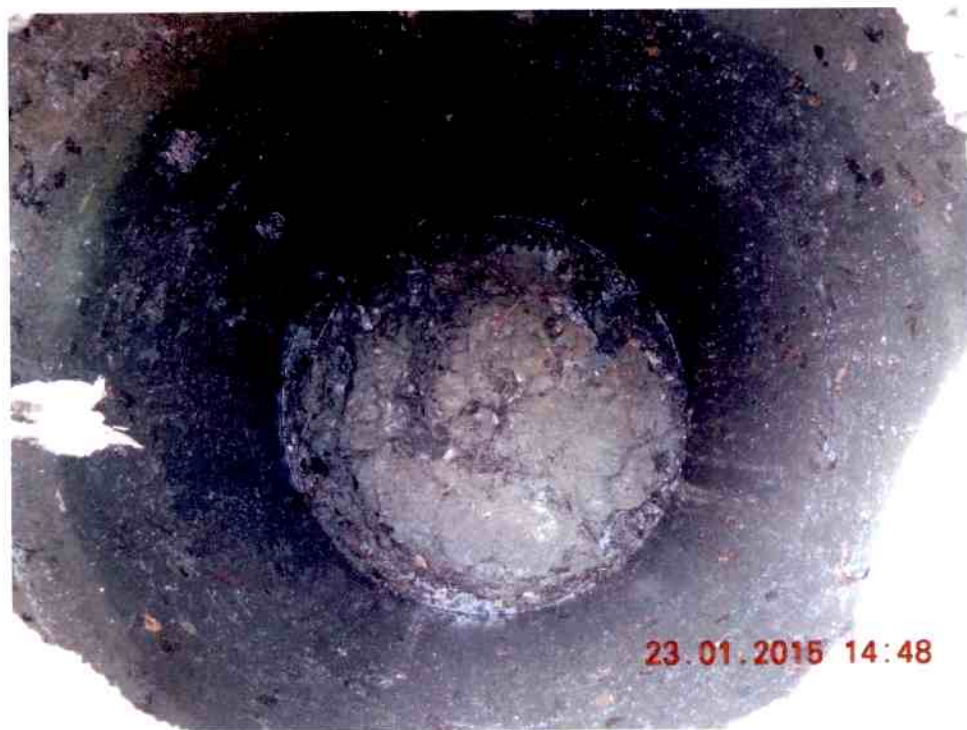
12. A wastewater manhole located at the east side of Condado and Ribot Streets intersection was found full of solids. See photos DSCN1722 and 1723 for more details.

**DSCN1723** – A wastewater manhole located at the east side of Condado and Ribot Streets intersection was found full of solids.

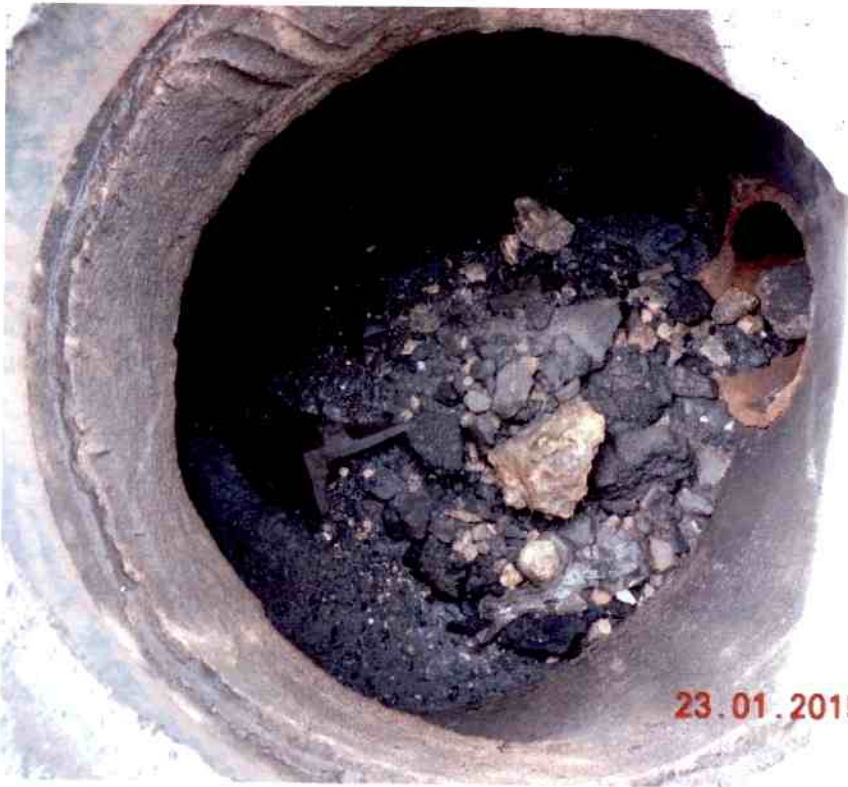
13. A storm water manhole located at the northeast side of Condado and Ribot Streets intersection was found obstructed by solids. See photo DSCN1724 for more details.

**DSCN1724** – Partial view of storm water manhole located at the east side of Condado and Ribot Streets intersection was found obstructed by solids.

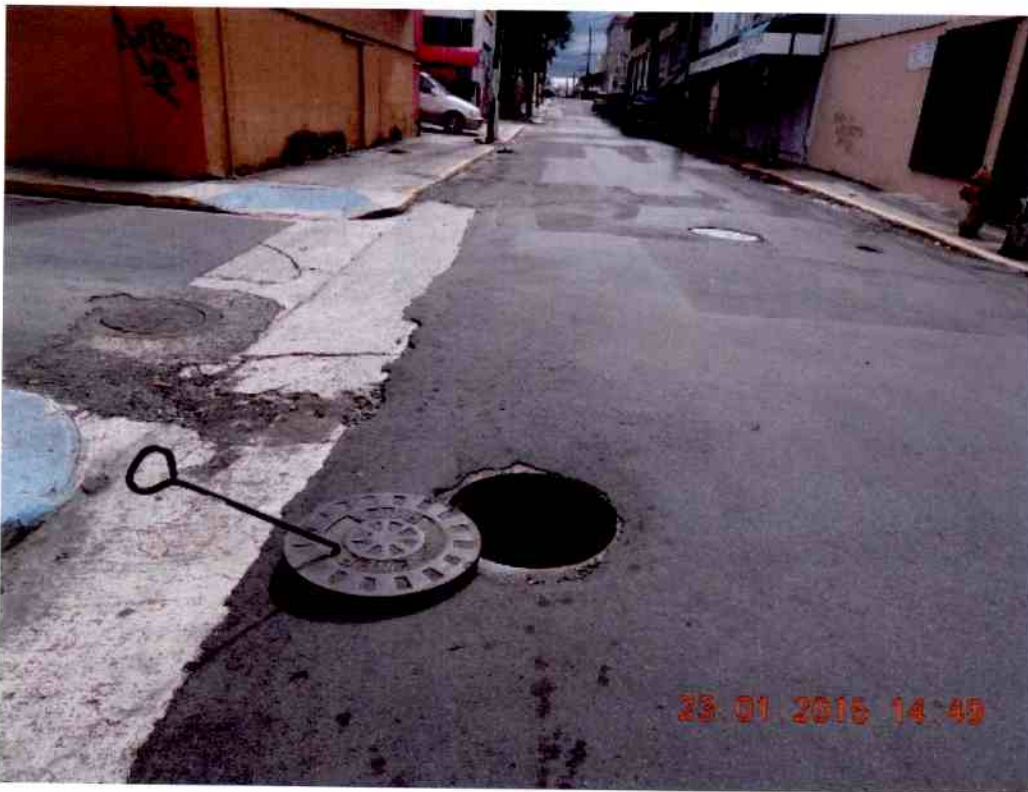
**DSCN1725** – View of northeast side of Ribot and Condado Streets intersection. The opened manhole in the photo is described in photo DSCN1724 above.
